## Garage Structural Repair

225 East 43<sup>rd</sup> Street

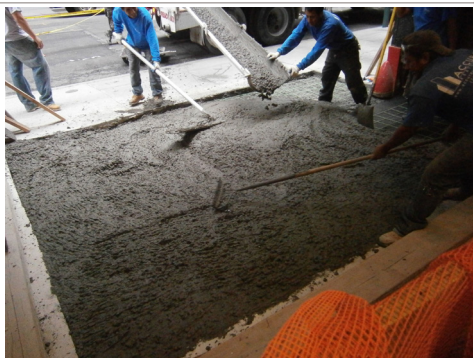
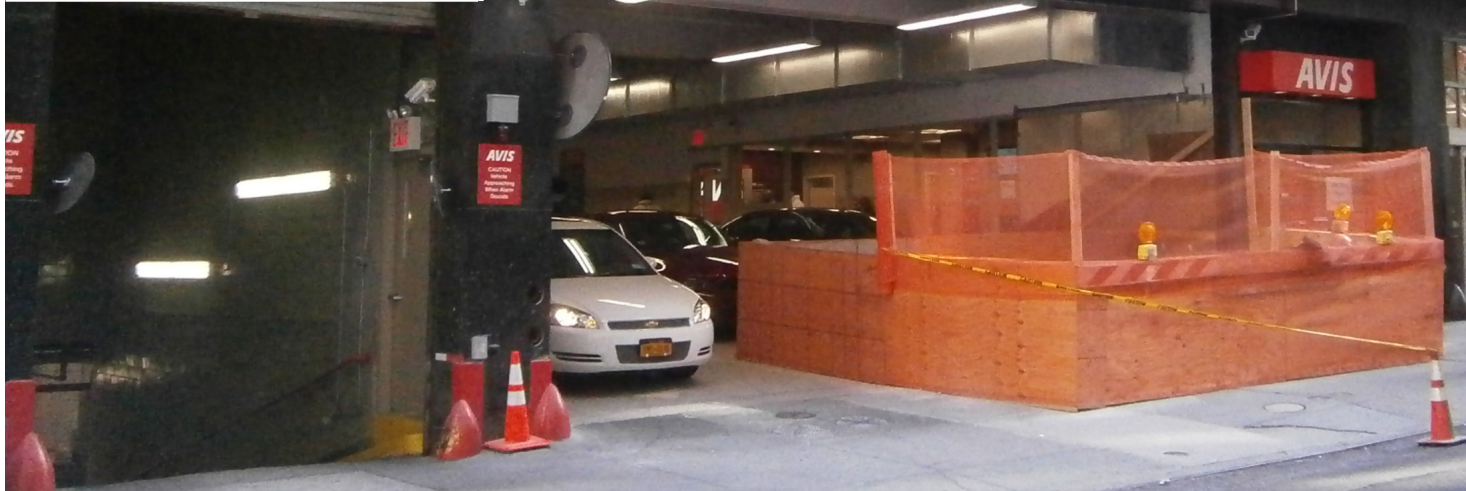
Persistent leaks in the parking garage led to extensive water damage, including badly deteriorated concrete and steel reinforcement. The repair work (inset) was phased so the vehicle rental facility could operate without interruption.

- Severely deteriorated concrete slab partially demolished and replaced
- Concrete sidewalk and masonry foundation wall reinforced
- Corroded steel framing refurbished and reinforced
- New waterproofing systems installed
- Work was phased to allow for uninterrupted operation of the vehicle rental facility
