# 9th Cycle FISP Repair Facade Inspection Safety Program

747 Third Avenue, Manhattan, NY

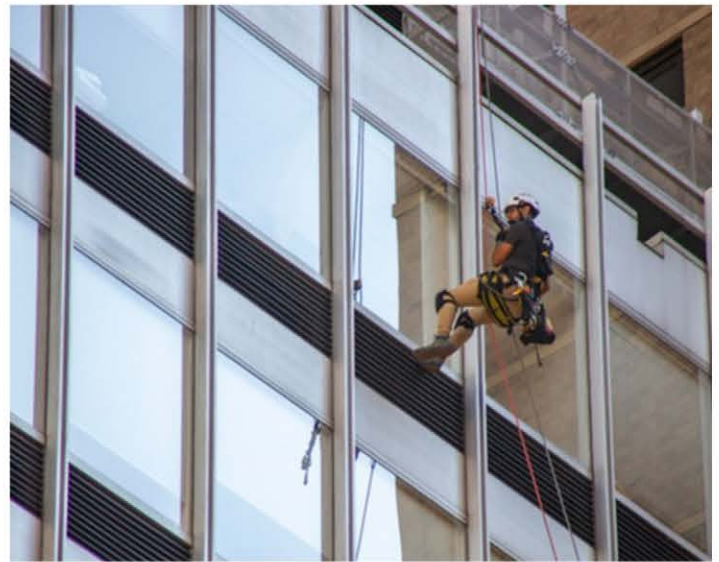
A member of RAND's in-house rope access team conducts a close-up FISP examination of the tower's glass curtain wall.

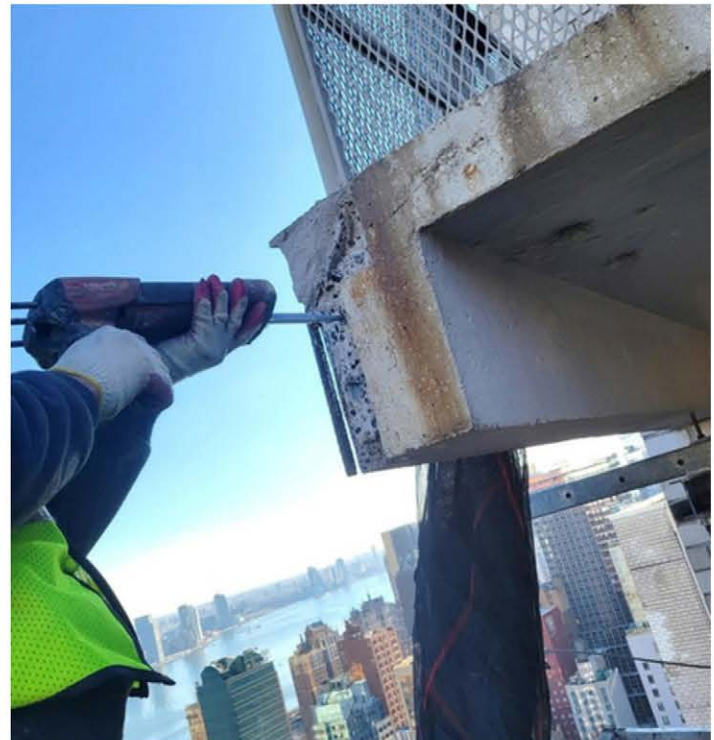
Deteriorated concrete was removed to sound substrate at the main-roof bulkhead as part of the localized concrete repair work.

- **Rooftop Concrete:** Examined and sounded the main-roof bulkhead stair landing and beam enclosures, completed approximately 75 square feet of concrete repairs, and applied pedestrian-grade and protective coatings to the repaired and exposed surfaces.
