**Mount Vernon Public Library**

**Roof Replacement & Exterior Repair; HVAC & Electrical Service Upgrade**

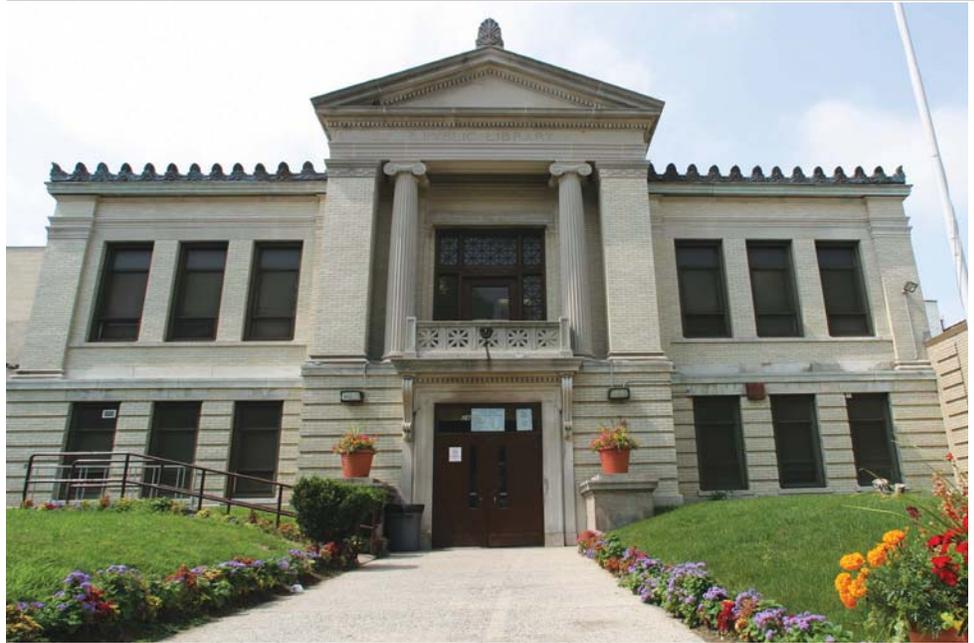
Mount Vernon Public Library replaced its badly deteriorated roof, which had been leaking for 15 years, causing damage to the library and its books.

- Removed the existing roof and installed a new monolithic polyurethane foam/silicone rubber roofing system with a 15-year No Dollar Limit warranty.
- Replaced defective brickwork and repointed mortar joints along the parapet, bulkhead, and chimney walls.
- Replaced the glass and metal skylight assembly above the lobby.
- Repaired sections of the stone cornice and the stone pediment.
- Rebuilt brick parapet walls and installed side-mounted railings.

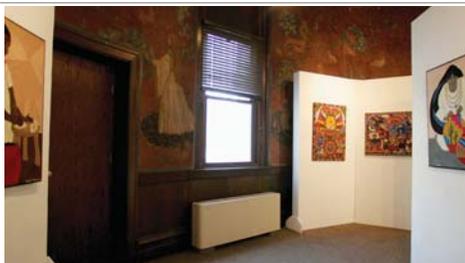
Fan coil units, such as this one in the library's art gallery, replaced window air conditioners, which were often broken.

- New high-efficiency, state-of-the-art HVAC system includes 47 indoor and nine outdoor condenser units featuring variable refrigerant volume and inverter technologies.
- All fresh air for the library supplied to the indoor units via concealed ductwork and inline fans.
- Fan controls interlocked with indoor units controls for efficient operation.
- New refrigerant and enclosed condensate drain copper piping.

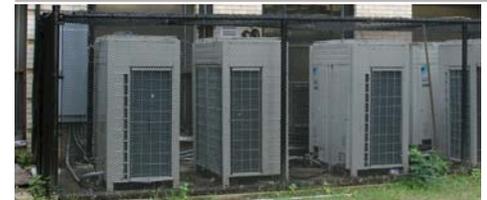
High-efficiency HVAC condenser units installed outside the building increased the library's heating and cooling capacity.

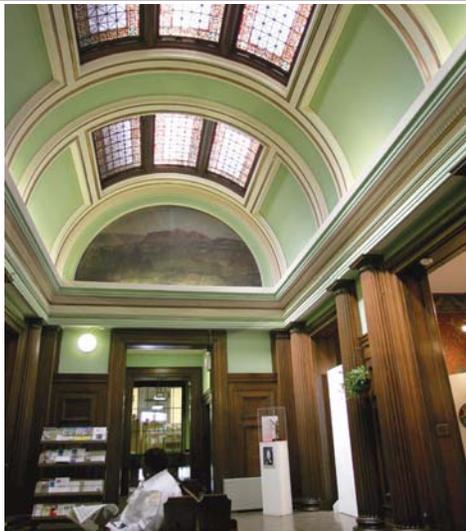
The enormous glass and metal skylight above the library's lobby was replaced.

refurbishing the enormous skylight over the lobby. The HVAC upgrade featured the installation of new heat pump condenser units and fan-coil units for more efficient heating and cooling, a new system of ductwork for better ventilation, and upgraded electrical equipment to service the new HVAC system.
